Manhole Inspection Summary

Manhole # S31E__019MH

Insp Date: **8/27/08 10:05 AM**

Location Address: **325 w lexington st**

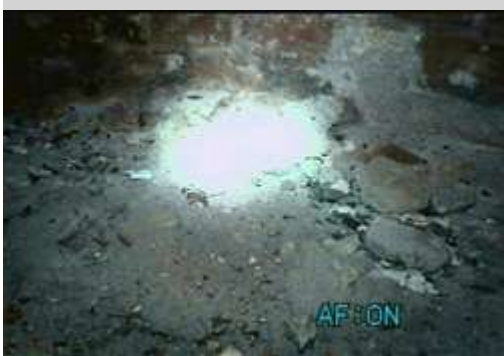
Misc

bench debris

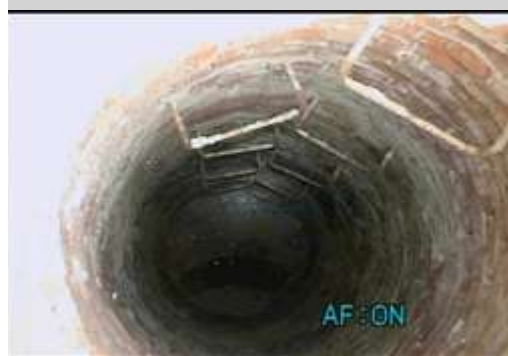
Defect 2

Steps Count: **9** Missing: **0** ☒ **Corroded**

steps

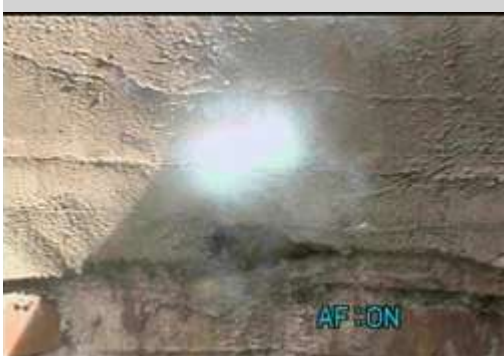
Defect 1

Condition: ☐ Sound ☒ **Cracked** ☐ Root Intrusion ☐ Loose Brick ☐ Deteriorated

chimney cracked, frame adj

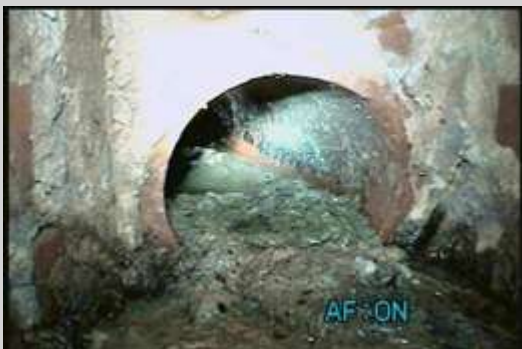
3 O'Clock Inflow

8 in. Circular Gravity Sewer
Pipe In @ 3 O'Clock

Deposits: ☐ None ☐ Mud ☒ ~~Gravy~~ ☒ **Debris** ☐ Grease

Silt Depth: 2 (in.) Deposits Extent: **Light**
